# **CASE STUDY**Chatterton Water Tower

## **Chatterton Water Tower**

Provision of an encapsulated scaffold structure around the iconic Chatterton water tower this enabled essential painting and repairs to the tower.

Location: Spalding

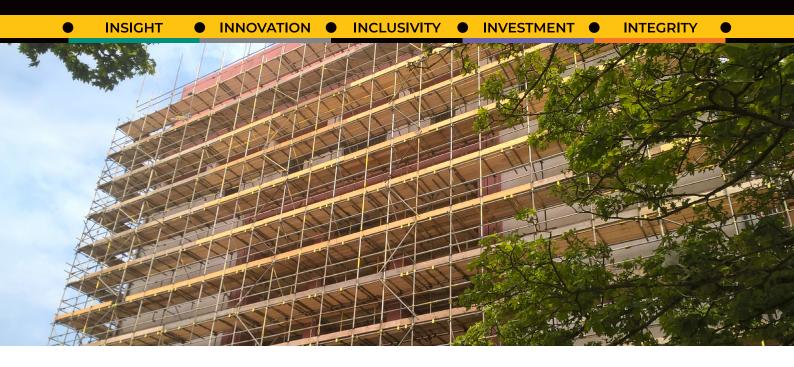
Our scope was to provide a fully encapsulated perimeter scaffold surrounding the Water Tower using more than 195 tonnes of scaffolding material. The scaffold structure was encapsulated with sheeting to protect the workers from the elements and to stop any environmental contamination. A team of eight scaffolders and four rope access operatives worked on the project to allow painting and repairs to the structure.

We specifically tailored the design of the roof scaffold, eliminating the risk of any scaffolding tubes piercing the roof, allowing the tower to continue operating, supplying essential water to local residences and businesses.
